Site Assessment Essentials

EPA Region III

CASE STUDY ABOUT PFAS BLADES GROUNDWATER

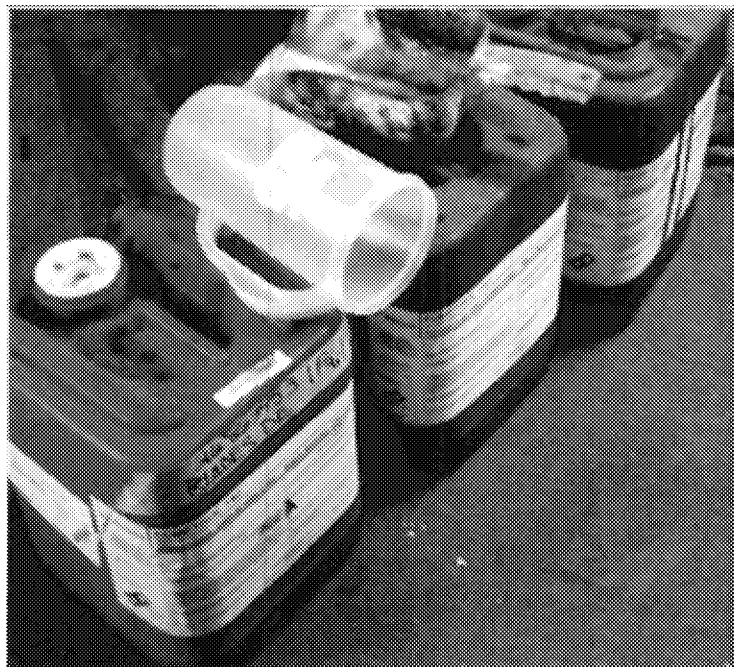
Fumetrol 140 - Specific Gravity:1.025
ORGANIC FLUOROSULFONATE 7% by volume

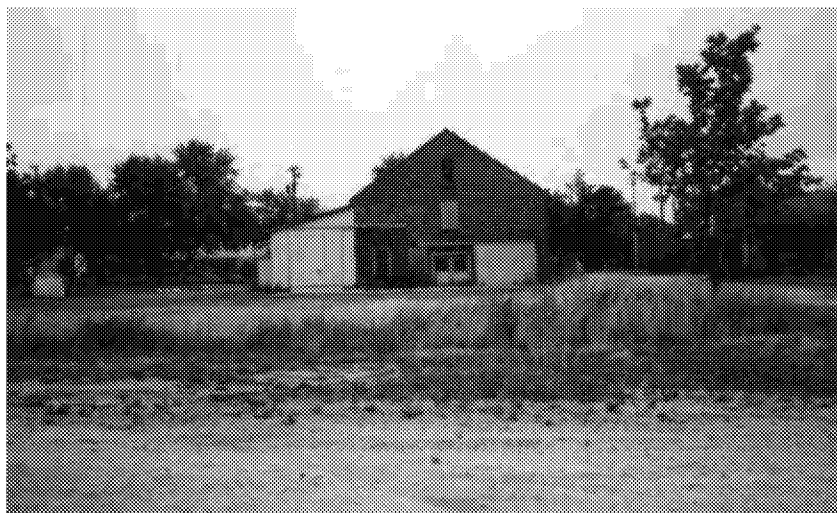
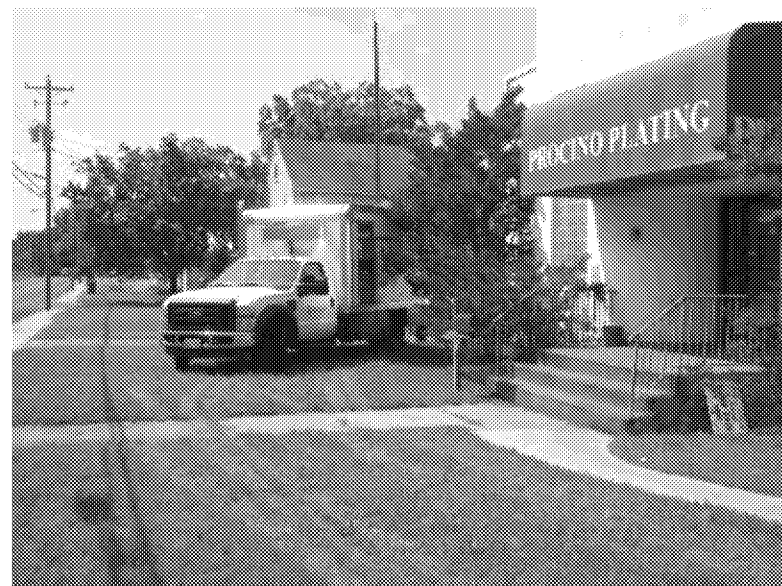
Investigation of the Blades Site

- ◆ Further assessment is continuing to determine the source(s) of this contamination.
- ◆ The contamination from both facilities may be comingled containing PFAS, chromium, and cyanide.
- ◆ Both facilities have used multiple types of plating processes.
